Manhole Inspection Summary

Manhole # S39GG1067MH

Record Plat: **39GG1** Node: **067** Status: **New Manhole (Not in GIS)** Insp Date: **11/12/08 12:00 AM**

Location Address: **805 ARGONNE DR**

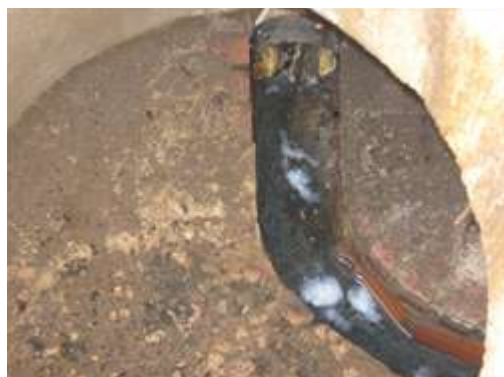
Top View

Surcharge ☒ Evidence Of Surcharge Depth: **1** (ft.) ☐ Active Surcharge Present

Evidence of surcharge - Bench debris.
Channel debris.

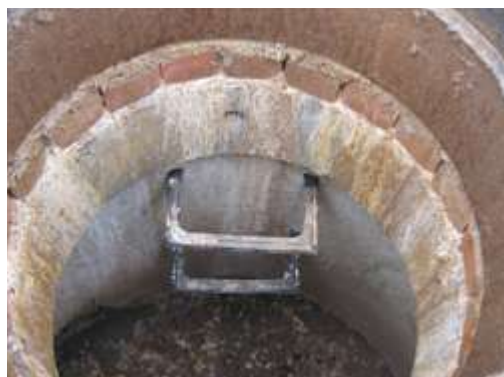
Defect

Frame leaks. Adjustment, Corbel and
Barrel infiltration.

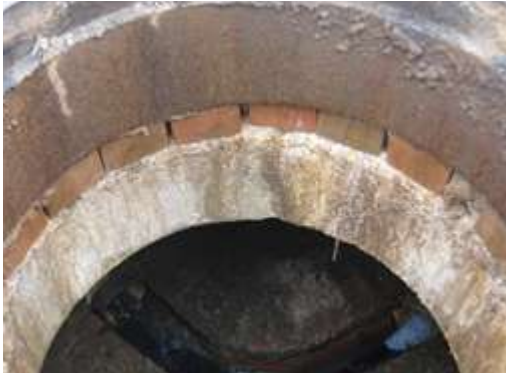
Defect

Frame leaks. Adjustment, Corbel and Barrel infiltration - other side.

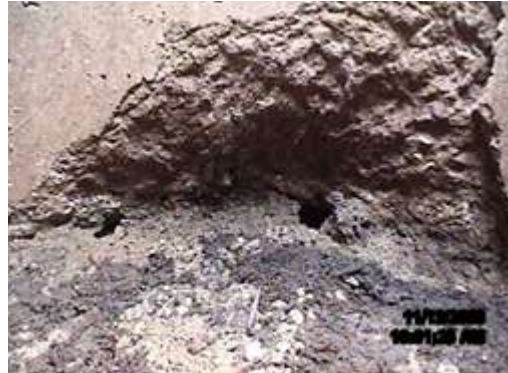
Defect

Barrel deterioration and infiltration.

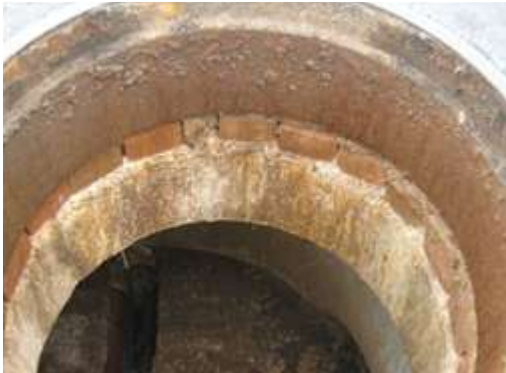
Defect

Frame leaks. Adjustment, Corbel and Barrel infiltration.

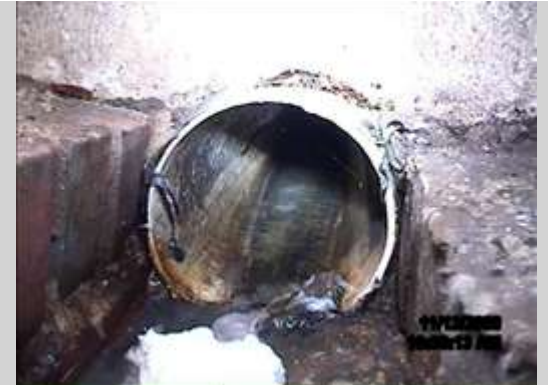
6 in. Circular Gravity Sewer Pipe Out @ 12 O'Clock

Invert Depth: **5.20** (ft.) Flow Characteristics: **Slow**

Infiltration: **Evidence** Pipe Seal Cond: **Unknown**

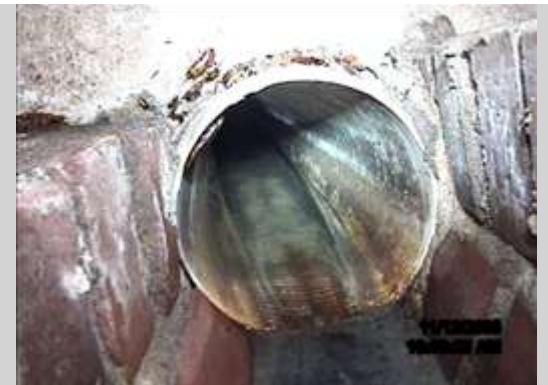
6 in. Circular Gravity Sewer Pipe In @ 4 O'Clock

Invert Depth: **5.16** (ft.) Flow Characteristics: **None**

Infiltration: **Evidence** Pipe Seal Cond: **Roots**
